# Drainage Report

## - CCTV Survey Report : 09/04/19

## Site: 5 St Hilda View , Audenshaw

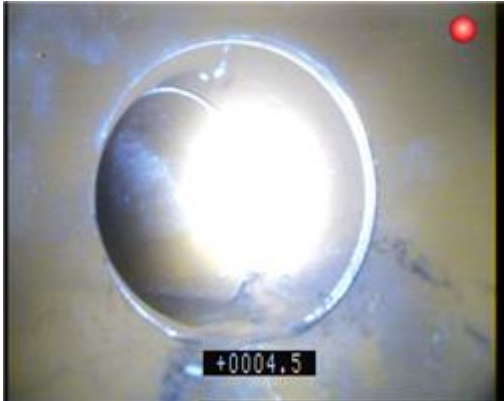
| Pos | Code | Description | Image |
|---|---|--|---|
| 04.50m | LLH | Line of drain/sewer deviates left [half]<br>Line of Drain deviates to the left | Image Provided - Ref: 0_2<br> |

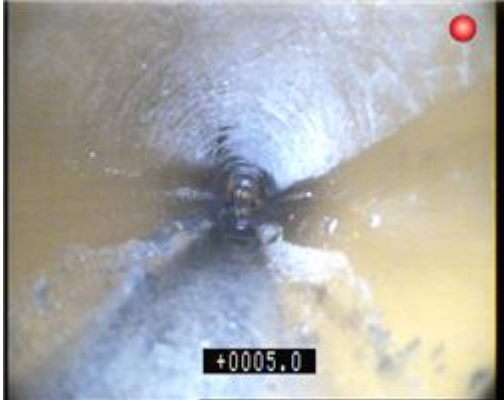
| Pos | Code | Description | Image |
|---|---|--|---|
| 05.00m | WL | Water level: 10% Height/Diameter | Image Provided - Ref: 0_3<br> |

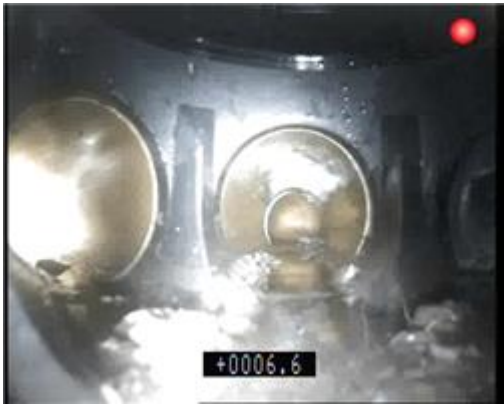
| Pos | Code | Description | Image |
|---|---|---|--|
| 06.60m | MHF | Finish node type, manhole<br>MHF line of drain finishes at at burried man<br>hold (Back Fall) | <p>Image Provided - Ref: 0_9999</p> |

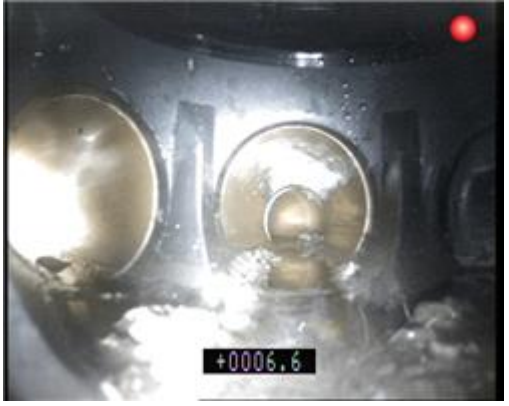
| Pos | Code | Description | Image |
|---|---|---|---|
| 00.00m | MH | Start node type, manhole MH | Image Provided - Ref: 1_0<br> |

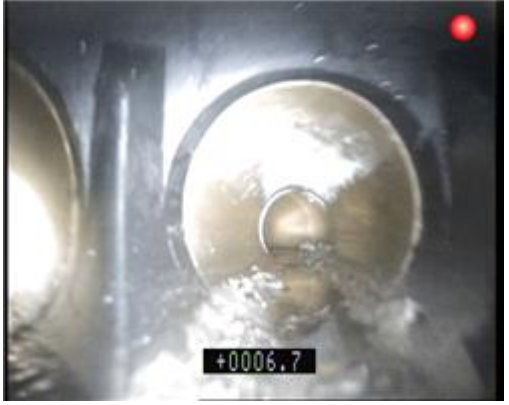
| Position | Code | Description | CD | Pic | Grade |
|---|---|--|---|---|---|
| 06.70m | DER | Settled deposits coarse 5% | | 1_2 | 3 |

| Pos | Code | Description | Image |
|---|---|---|---|
| 06.70m | DER | Settled deposits coarse: 5% Cross sectional area loss - Grade 3 settled deposits | Image Provided - Ref: 1_2<br> |

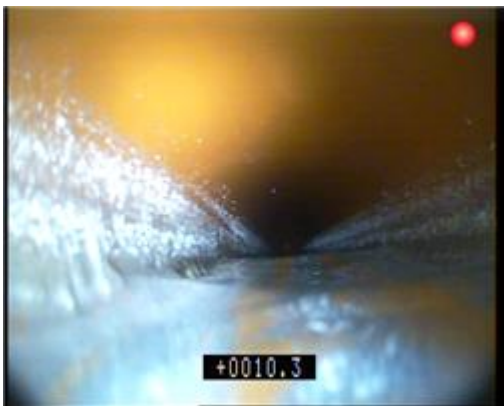
| Pos | Code | Description | Image |
|---|---|---|---|
| 10.30m | WL | Water level: 40% Height/Diameter | Image Provided - Ref: 1_6<br> |

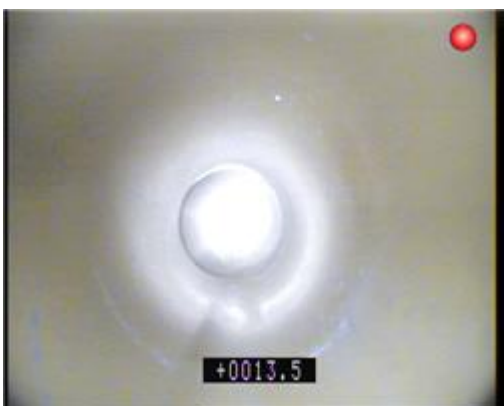
| Pos | Code | Description | Image |
|---|---|---|---|
| 13.50m | WL | Water level: 5% Height/Diameter<br>water level decreases significantly here | Image Provided - Ref: 1_7<br> |

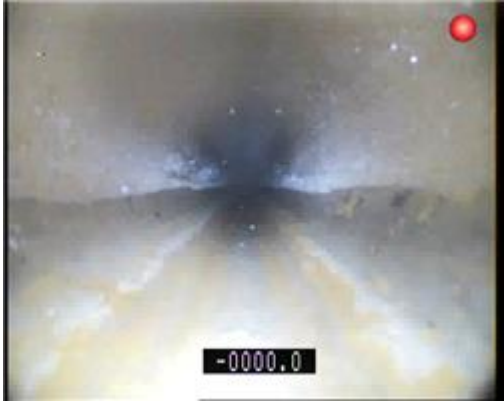
| Pos | Code | Description | Image |
|---|---|--|---|
| 00.00m | MH | Start node type, manhole MH1 | Image Provided - Ref: 2_0<br> |

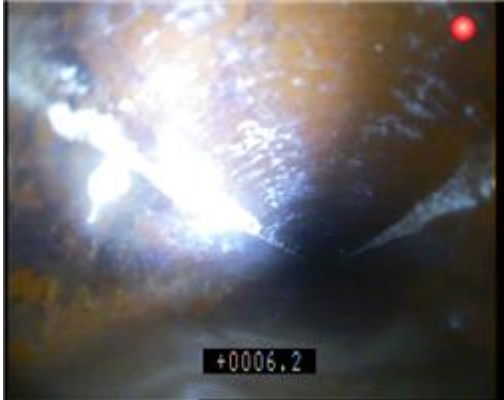
| Pos | Code | Description | Image |
|---|---|--|---|
| 05.30m | LLH | Line of drain/sewer deviates left [half]<br>Line of drain deviates to the left at this point | Image Provided - Ref: 2_2<br> |

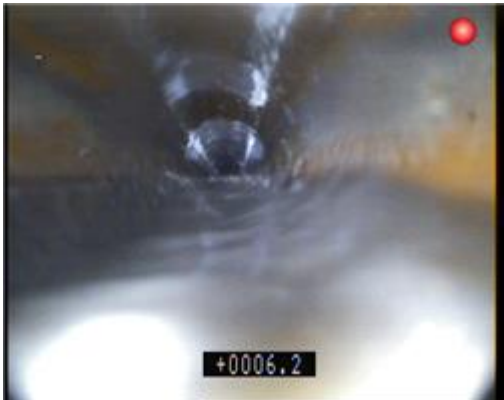
| Pos | Code | Description | Image |
|---|---|--|---|
| 06.20m | WL | Water level: 30% Height/Diameter<br>water level increases here due to solid deposits | Image Provided - Ref: 2_3<br> |

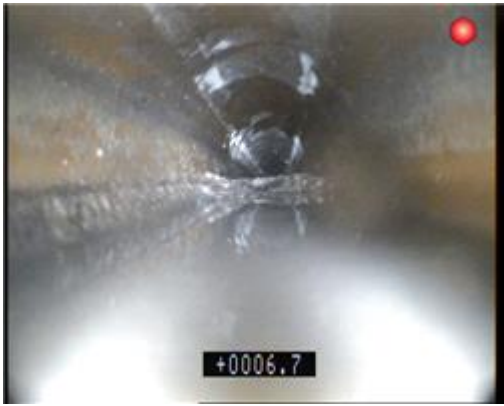
| Position | Code | Description | CD | Pic | Grade |
|---|---|---|---|---|---|
| 06.70m | DEE | Attached deposits, encrustation 04-07 30% | | 2_4 | 3 |

| Pos | Code | Description | Image |
|---|---|--|---|
| 06.70m | DEE | Attached deposits, encrustation from 04 o'clock to 07 o'clock: 30% Cross sectional area loss - Grade 3<br>attached deposits within drain preventing water from draining completely | Image Provided - Ref: 2_4<br> |
